Santa Clara River Estuary Habitat Restoration and Enhancement Feasibility Study

EXISTING CONDITIONS TECHNICAL REPORT

January 7th, 2015

Project Number: 14-1023

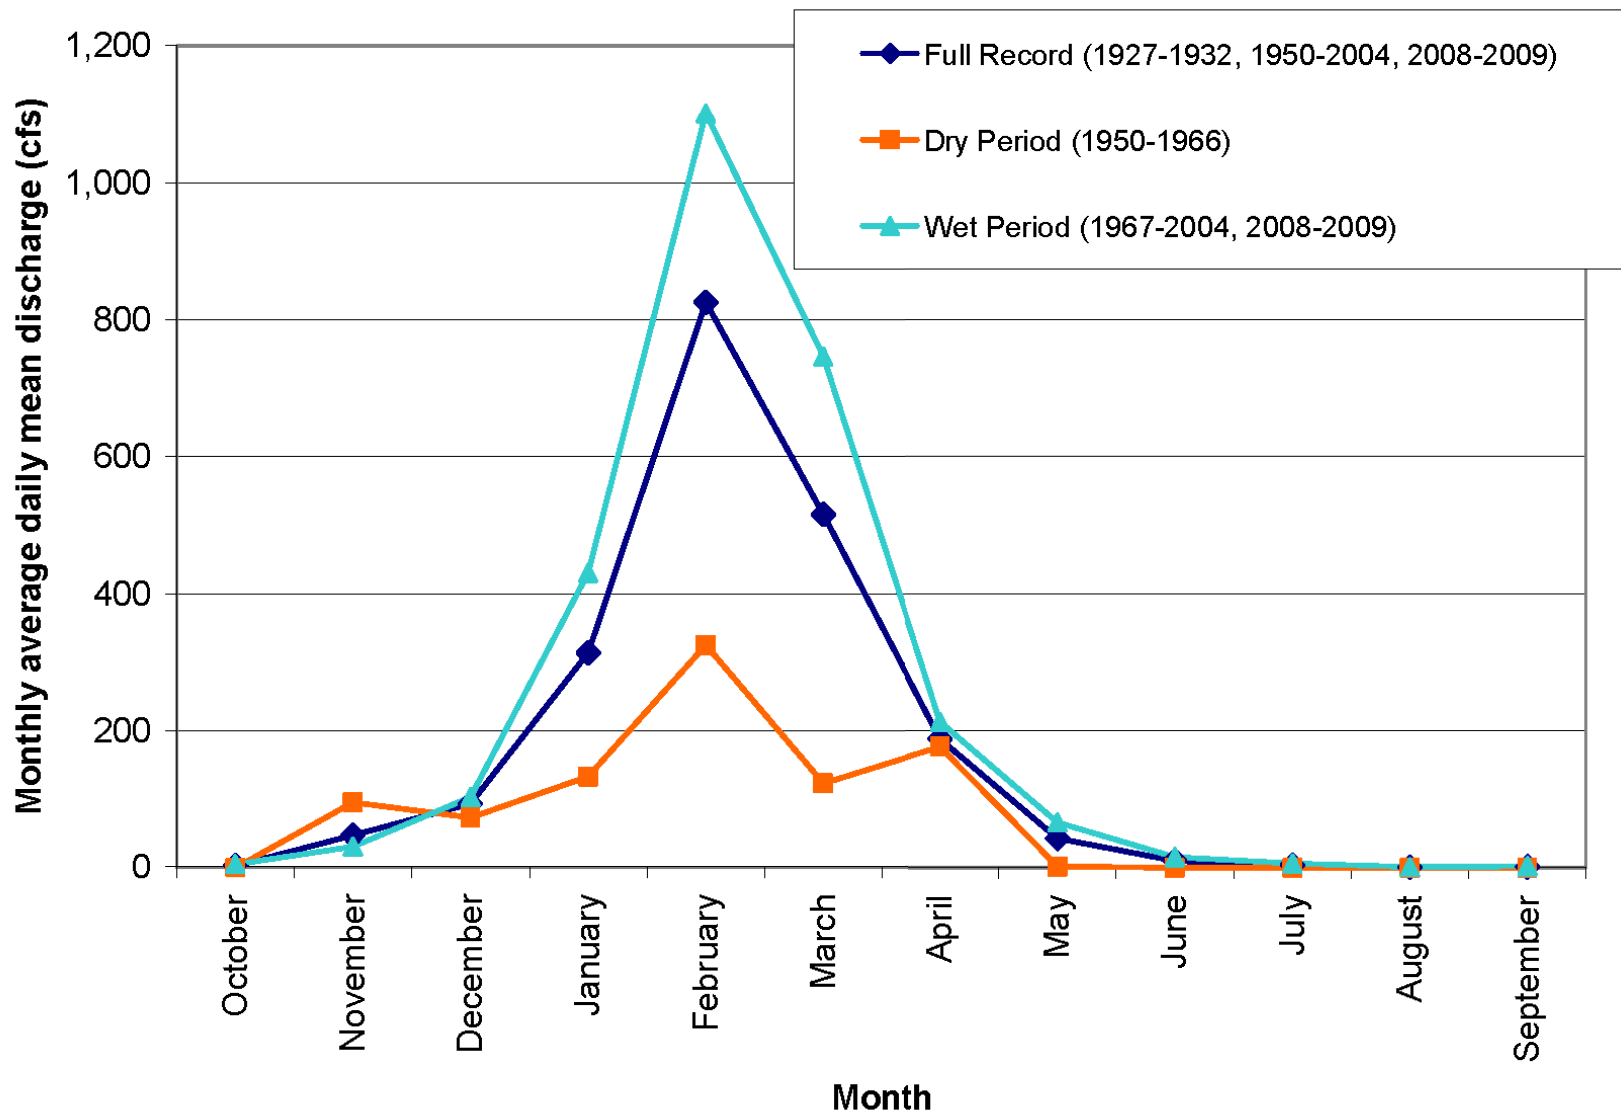
Project No. 14-1023	Created By: DT/DM	Figure 15
---------------------	-------------------	------------------

Source: Adapted from Stillwater Sciences, 2011.
 Notes: USGS gage #11114000 Santa Clara River at Montalvo and VCWPD gage #723 Santa Clara River at Victoria Ave. Wet periods and dry periods as observed in the hydrologic record not necessarily correlated with short term ENSO fluctuations.

Santa Clara River monthly mean discharge

The flow data retrieved from these gages indicate that, over the period of record, the SCR has low to no surface water flow in the summer and fall months (see Section 3.2 for a discussion of historical low flow conditions), but reacts quickly to high intensity storm events that occur in the winter and spring months. While daily average discharges range from 0 to over 90,000 cfs, Stillwater Sciences (2011) observed that over the course of a water year flows are usually less than 1 cfs (70% of the time) and rarely exceed 100 cfs. In general, low flows occur from May through December with the highest flows typically occurring in February. Monthly average daily mean discharges, for both wet years (ENSO dominated periods) and dry years (non-ENSO periods), are shown in Figure 15.

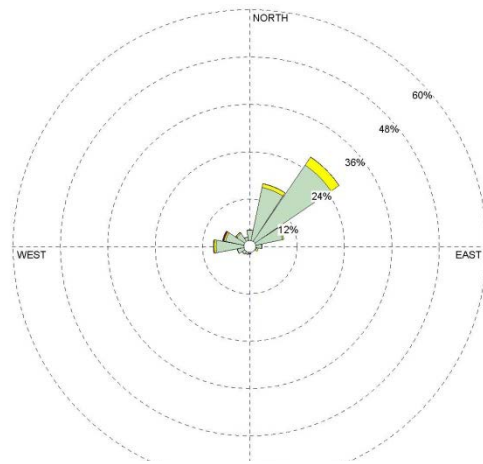
Figure 18

1:00 Hours, Average wind speed= 1.13 m/s

2:00 Hours, Average wind speed= 1.13 m/s

3:00 Hours, Average wind speed= 1.14 m/s

4:00 Hours, Average wind speed= 1.15 m/s

5:00 Hours, Average wind speed= 1.17 m/s

6:00 Hours, Average wind speed= 1.22 m/s

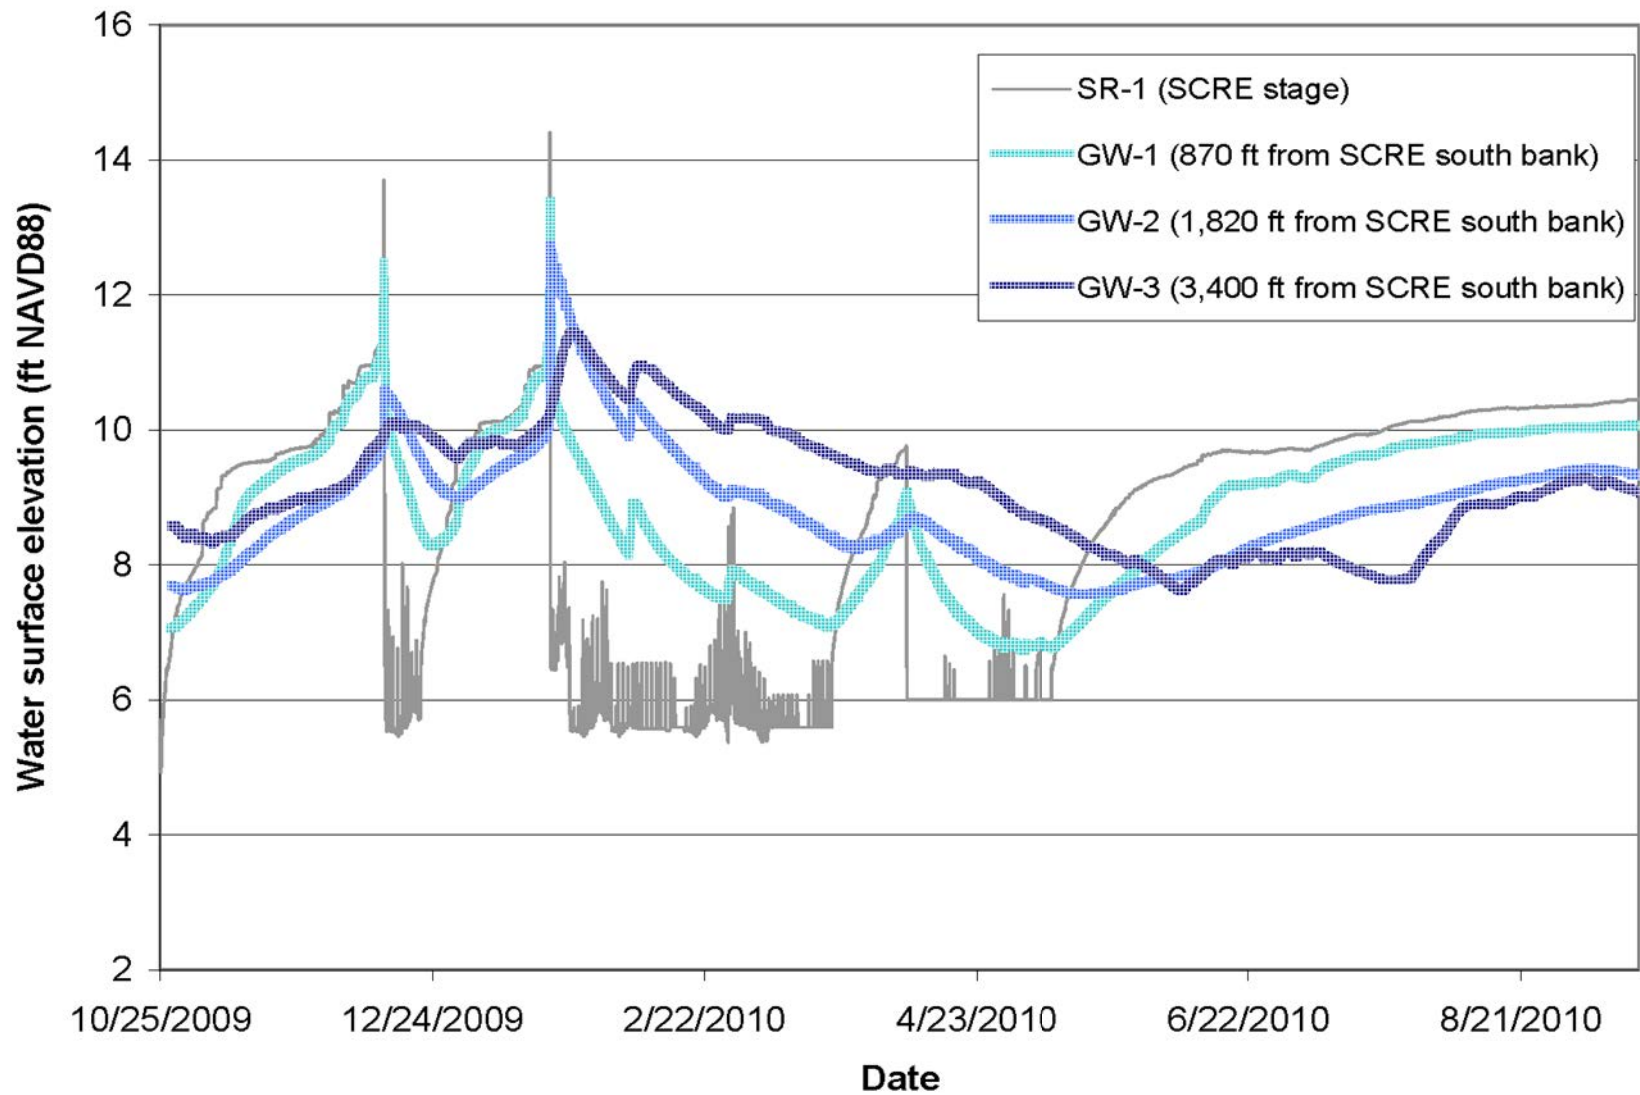
Figure 27

Source: Adapted from Stillwater Sciences, 2011.
 Notes: SCRE stage and adjacent groundwater elevation between October 25, 2009 and September 15, 2010 as measured at the South Sonde and GW-1, GW-2, GW-3. See Figure 25 for locations.
